NASA Engineering and Safety Center (NESC) Technical Assessment Report	Document #: RP-05-117	Version: 1.0
Title: NESC AN-Type Fittings in the International Space System (ISS) Node 2 Ammonia System Technical Assessment Report			Page #: 1 of 131

AN-Type Fittings in the International Space System (ISS) Node 2 Ammonia System Technical Assessment Report

October 27, 2005

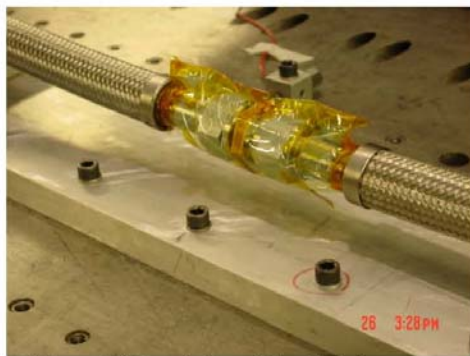
Figure 2. "Baggie-Type" Leak Test Bags

Two methods of leak testing were done during the Mimic Test. The quantitative leak test method was the "Baggie-Type" helium leak test, per NASA specification SSP 41172 Rev U, 4.2.11.2H Test Description and Alternatives, Method VIII – Accumulation. The maximum acceptable leak rate is 3.6×10^{-4} sccs He at 500 psia per seal. The time required for the system to be at pressure is 5 minutes prior to taking the reading instead of the required 30 minutes referenced in the current version of SSP 41172. At the time Alenia performed their leak checks, Method VIII was not included in SSP 41172. This 5 minute period is the approximate minimum wait time Alenia used during their "Baggie-Type" leak checks. The "Baggie-Type" leak test method produces an actual quantifiable leak rate value.

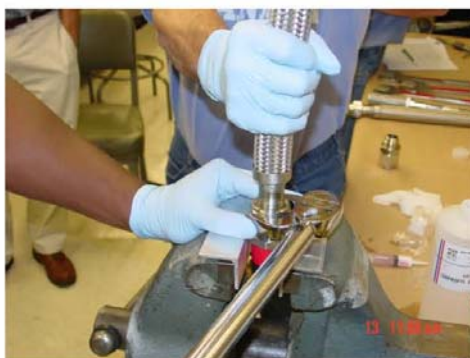
Figure 5. Torque Application During Assembly

The assembly process for the Test Article strived to use the same techniques and assembly procedures for all Test Articles. Special attention was given to consistently duplicate the thread lubrication techniques, the sealing surface cleaning methods, and the method of multi-torquing the fittings.

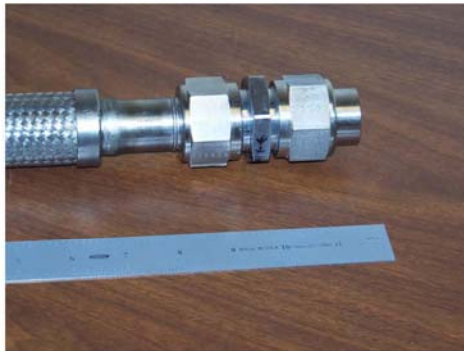
Figure 6 Surface Finish Test Assembly

Since, the test data showed that flex hoses with a 100 μ -inch surface finish would likely pass the acceptance leak test, the assessment team felt it was necessary to perform the full mimic test using flex hoses with a 100 μ -inch surface (Mimic Test-Series B).
